CORROSION AND ABRASION: THE FINAL FRONTIER

NEW SOLUTIONS FOR CORROSION AND ABRASION IN CEMENT PLANTS

BY LINAS MAZEIKA, PRESIDENT 3L&T INC.

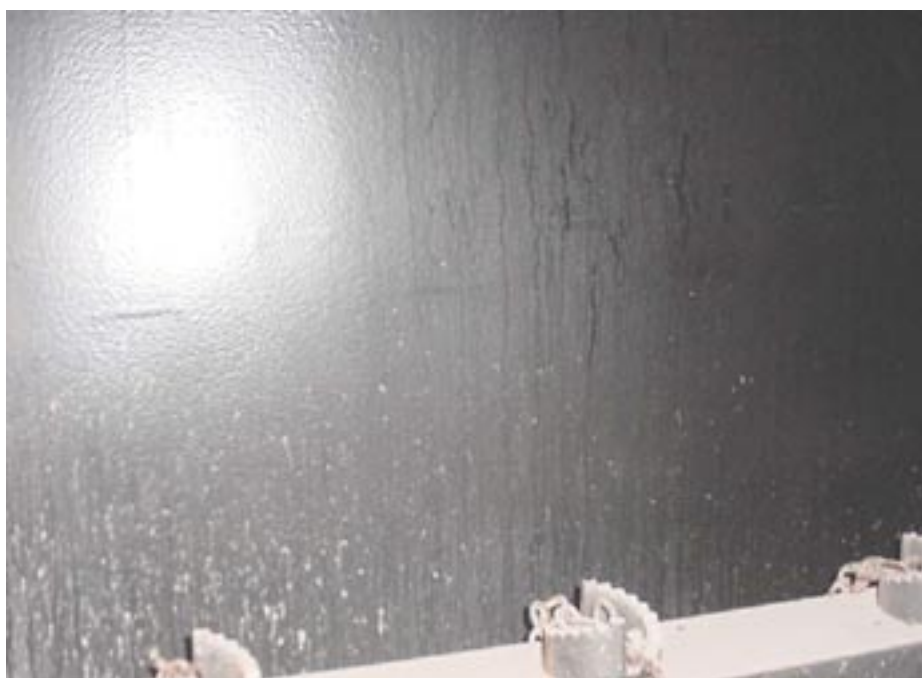
Fig 1. Baghouse wall coated with FlueGard-225SLB, two years previously.

Three years ago, 3L&T Inc. introduced a new corrosion protection technology called FlueGard-225, with a focus on baghouse filter corrosion. Today, after four upgrades, this coating material is being used around the world. Figure 1 shows the condition of a baghouse inspected after the application of FlueGard-225 two years pre-

viously. There has been no corrosion.

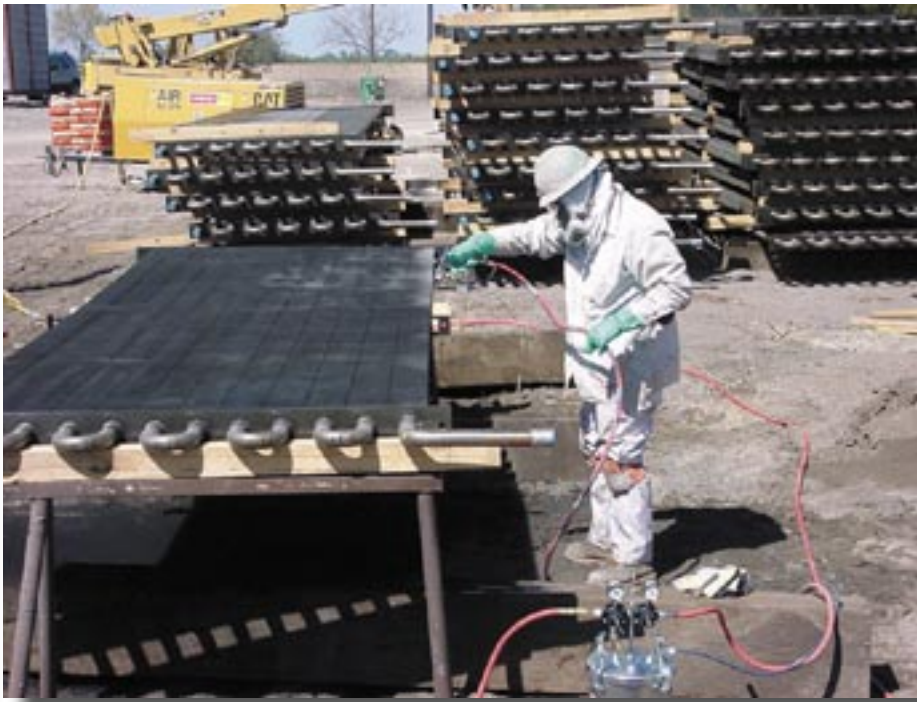
Figure 2. Application of FlueGard-325S on an economiser.

This new coating material - called FlueGard-325 - can sustain continuous operating temperatures of 325°C and short peaks up to 500°C. So far, it has been used on two heat economisers in power plants and will be installed in two cement plant baghouse filters, one in the UK and one in Mexico. The Figure 2 shows a recent application on the exterior of a finned tube economiser that operates at 290°C.

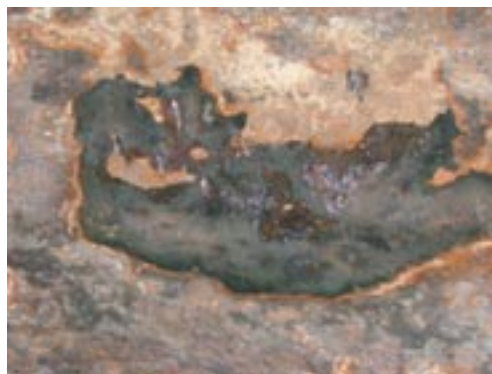
Figure 3: Kiln shell corrosion under the refractory, up to 8mm in thickness.

The outside shell temperature of a cement kiln is usually around 250°C. In some cases, especially in plants that use a large proportion of alternative fuels, there is severe corrosion of the inside shell under the refractory. One unusual characteristic of the thick slabs of corroded

steel that come off the shell is that it is strongly magnetic, this indicates that the material has a high content of Fe₃O₄.

For this situation we developed another inorganic, nano-particle composite designated as KilnGard-600. This material will resist corrosion and abrasion up to 600°C of continuous operation. The first successful applications were in Mexico and in Italy. This year we will be making two more applications in Italy. Figure 3 shows typical corrosion damage in the shell of a kiln, under the refractory: the corrosion slabs are up to 8 mm in thickness.

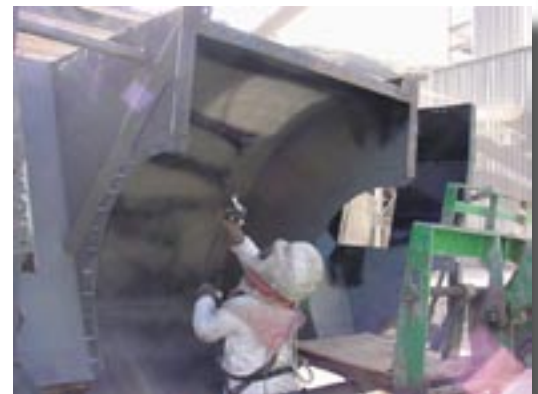
Figure 4: Coating of a fan housing to protect it from abrasion-corrosion.

The recently introduced WearGard-200 is intended to fill that gap. The first application was in the housing of a fan in Oregon, while subsequent installations will be in the housing of a screw conveyor in Texas and the static separator of a raw mill in Spain. Figure 4 shows the application in a housing fan that operates at 160°C, to protect it from abrasion-corrosion damage

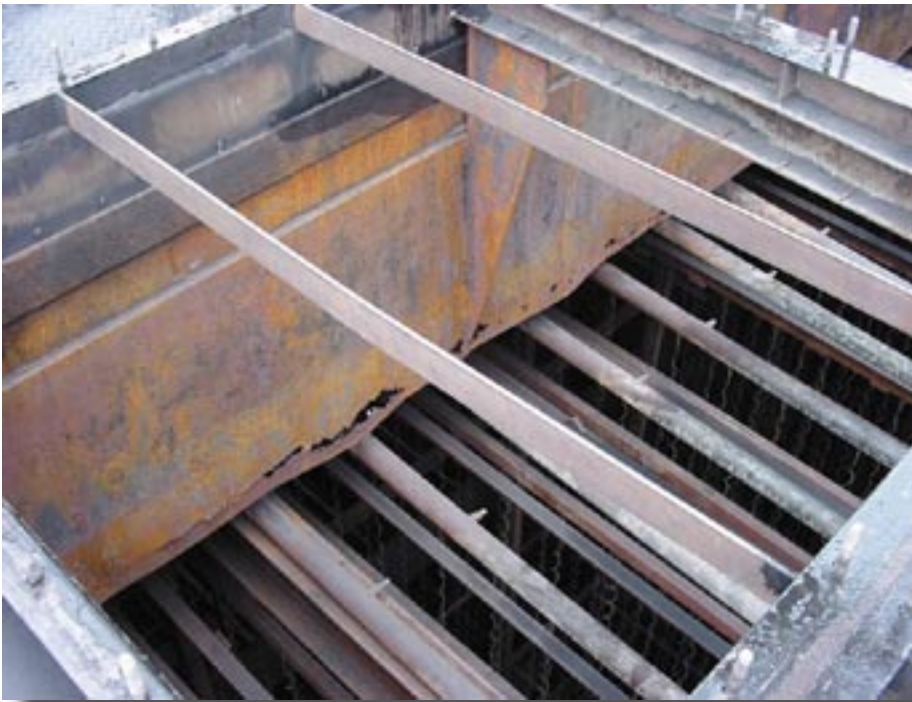
Figure 5. Severe corrosion in an electrostatic precipitator.

The Figure 5 shows the effects of corrosion on a stainless steel electrostatic separator: this is typically due to the presence of chlorides in the gas stream.

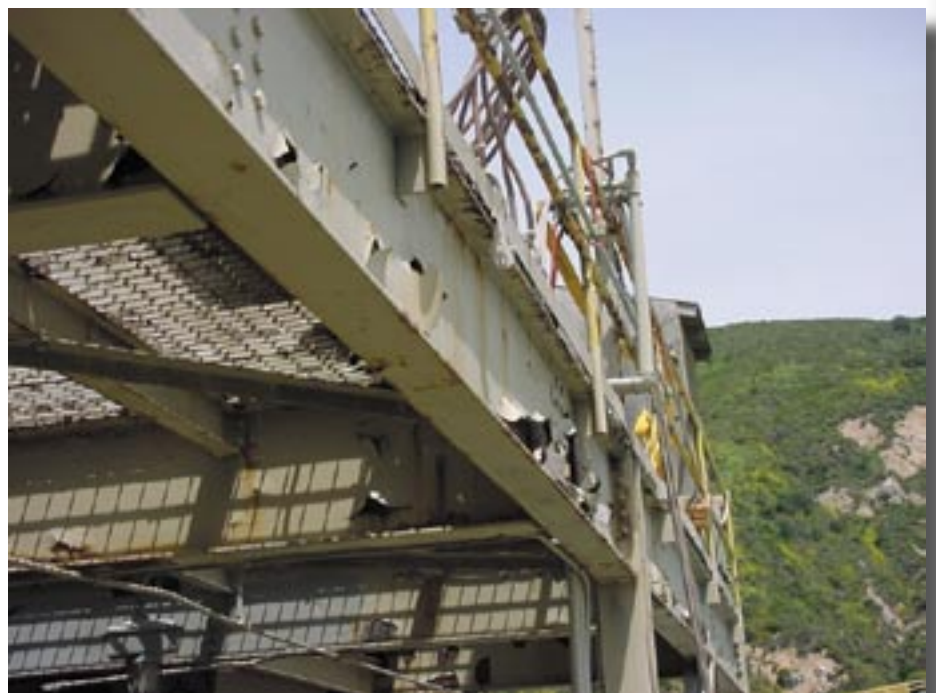
Figure 6: Severe corrosion of structural steel.

The results were better than any of the benchmarks coatings used for comparison. The first application in an aggregate plant in California looks very good after several months in service. Figure 6 shows the type of corrosion damage that is common in structural steel exposed to marine or industrial environment.
