FlueGard-225SLB at Obourg ESP

November 2004

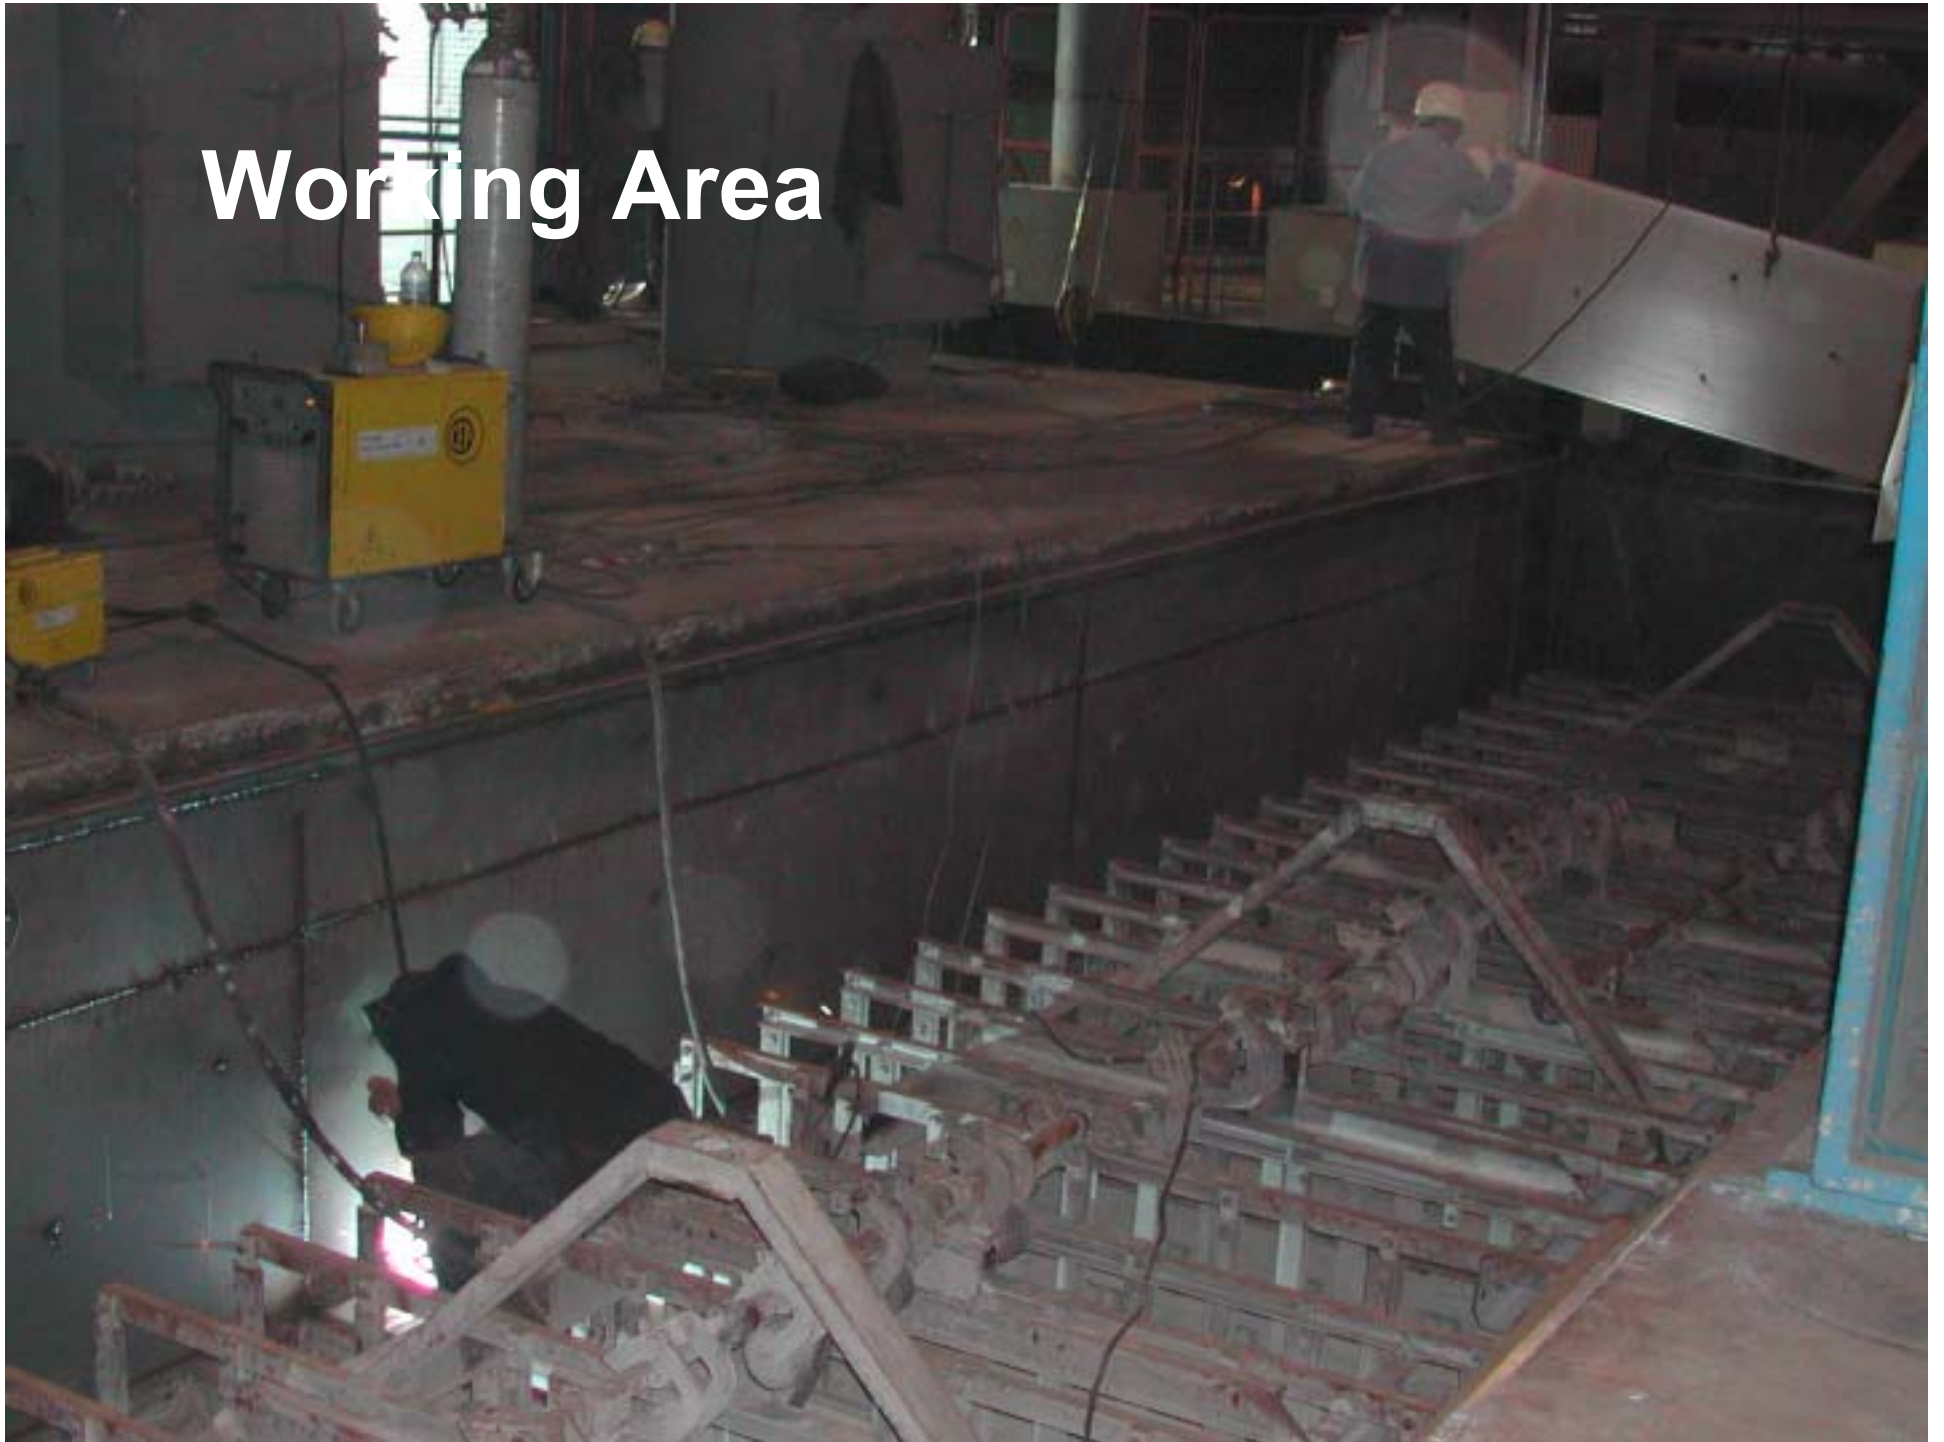
Working Area

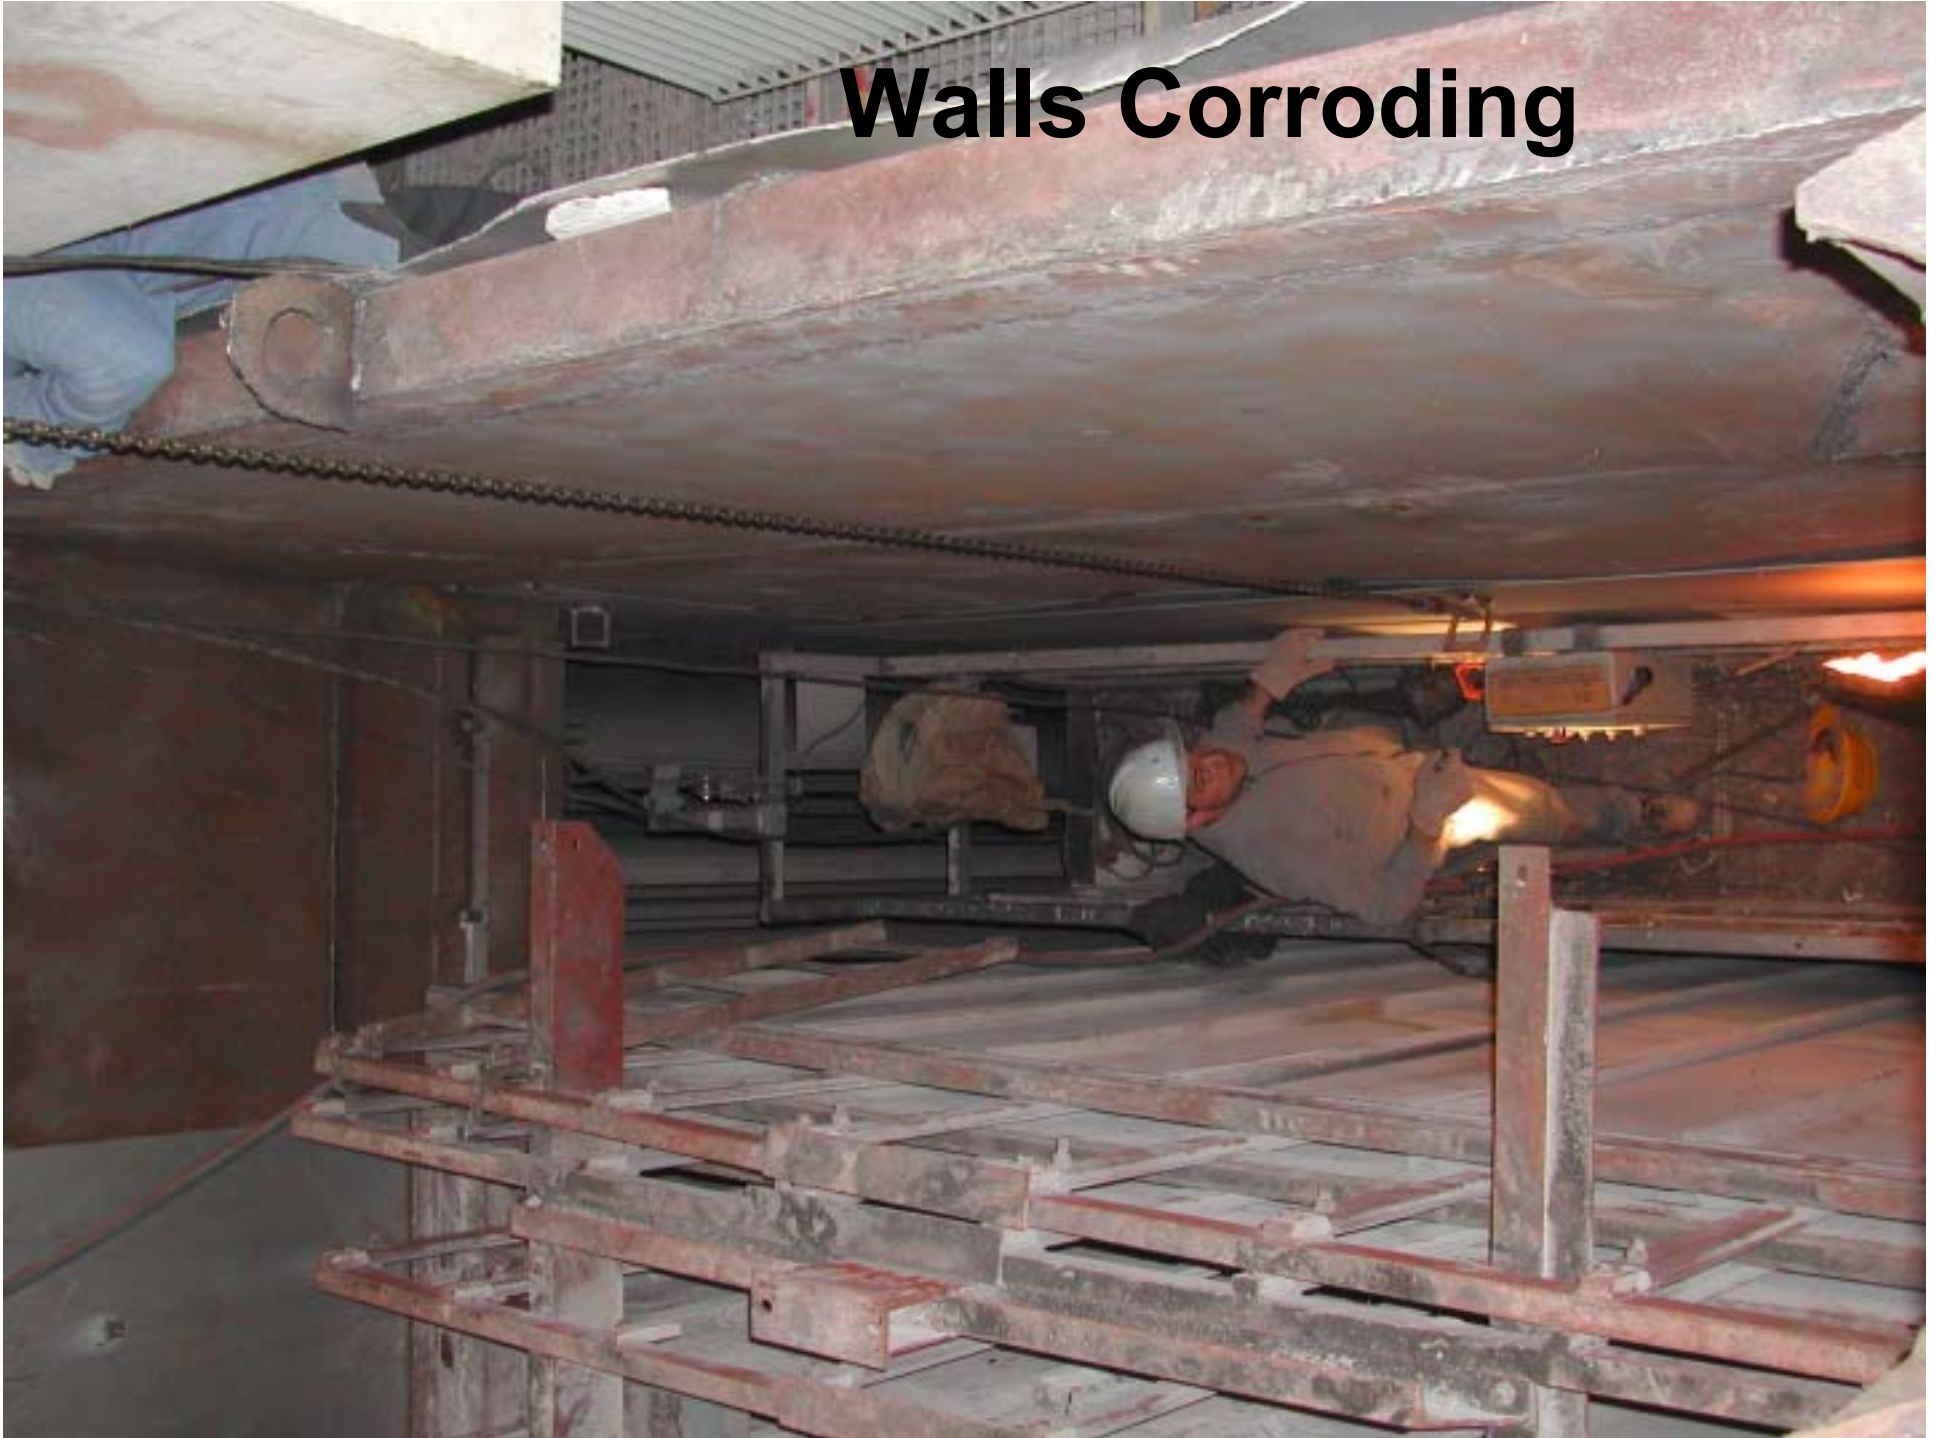
Walls Corroding

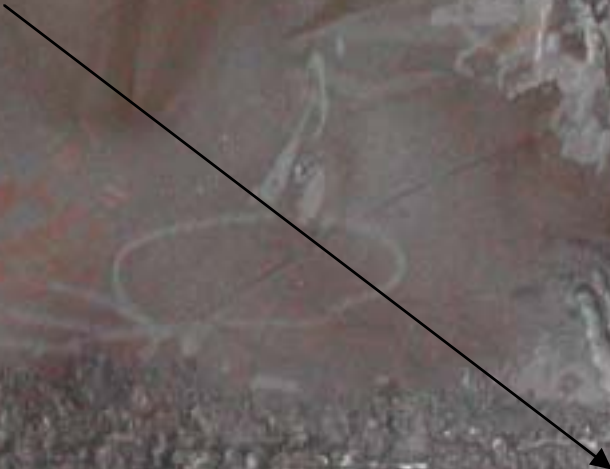
Stainless Steel Corroded

Welds gone!

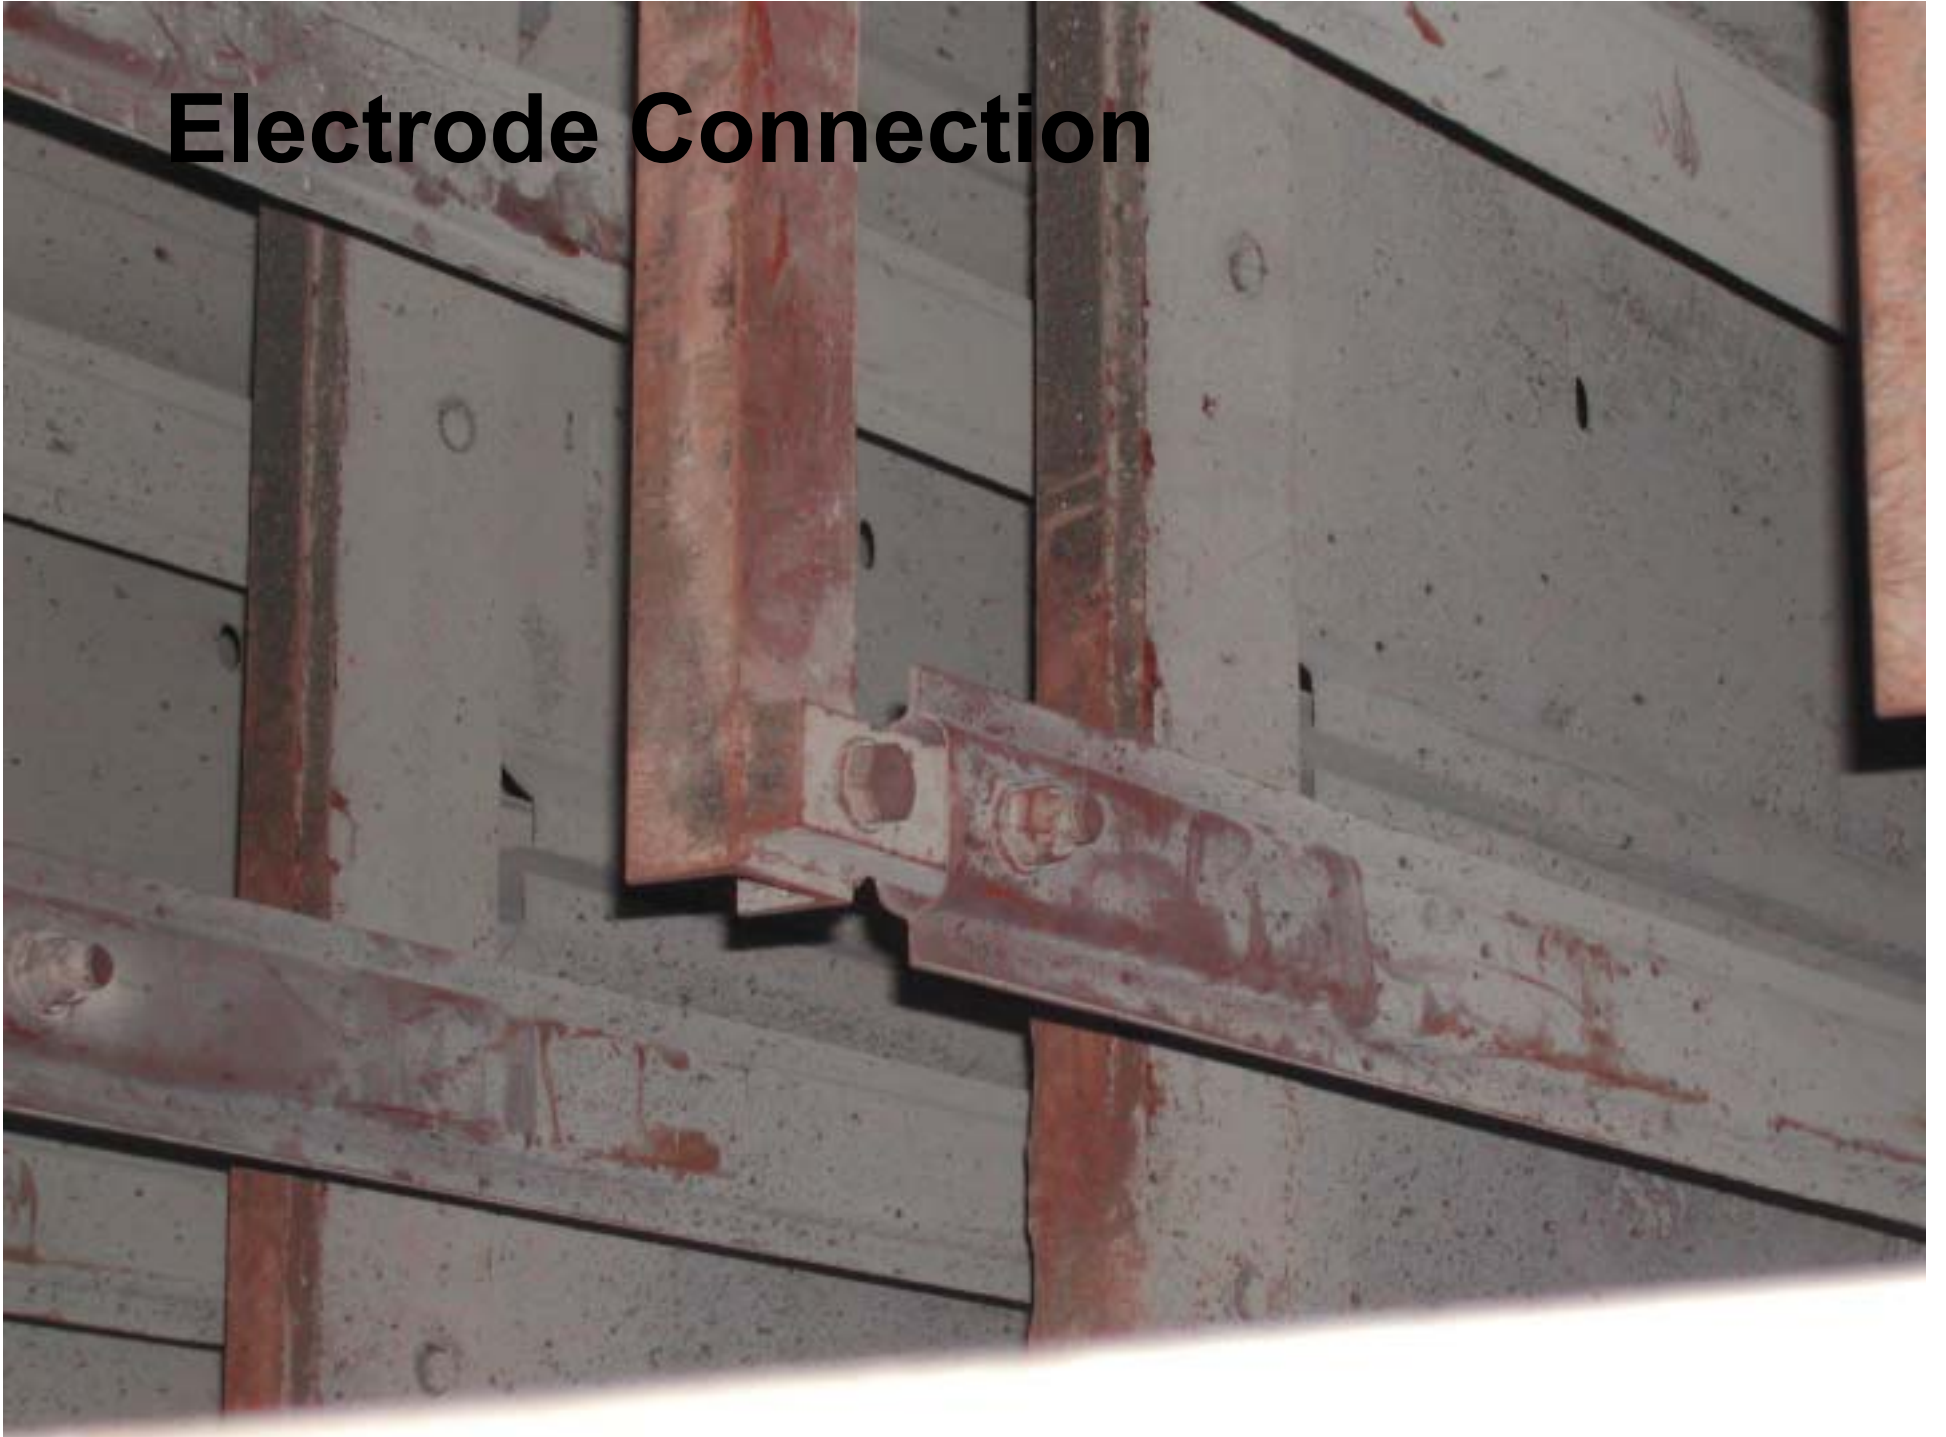
Electrode Connection

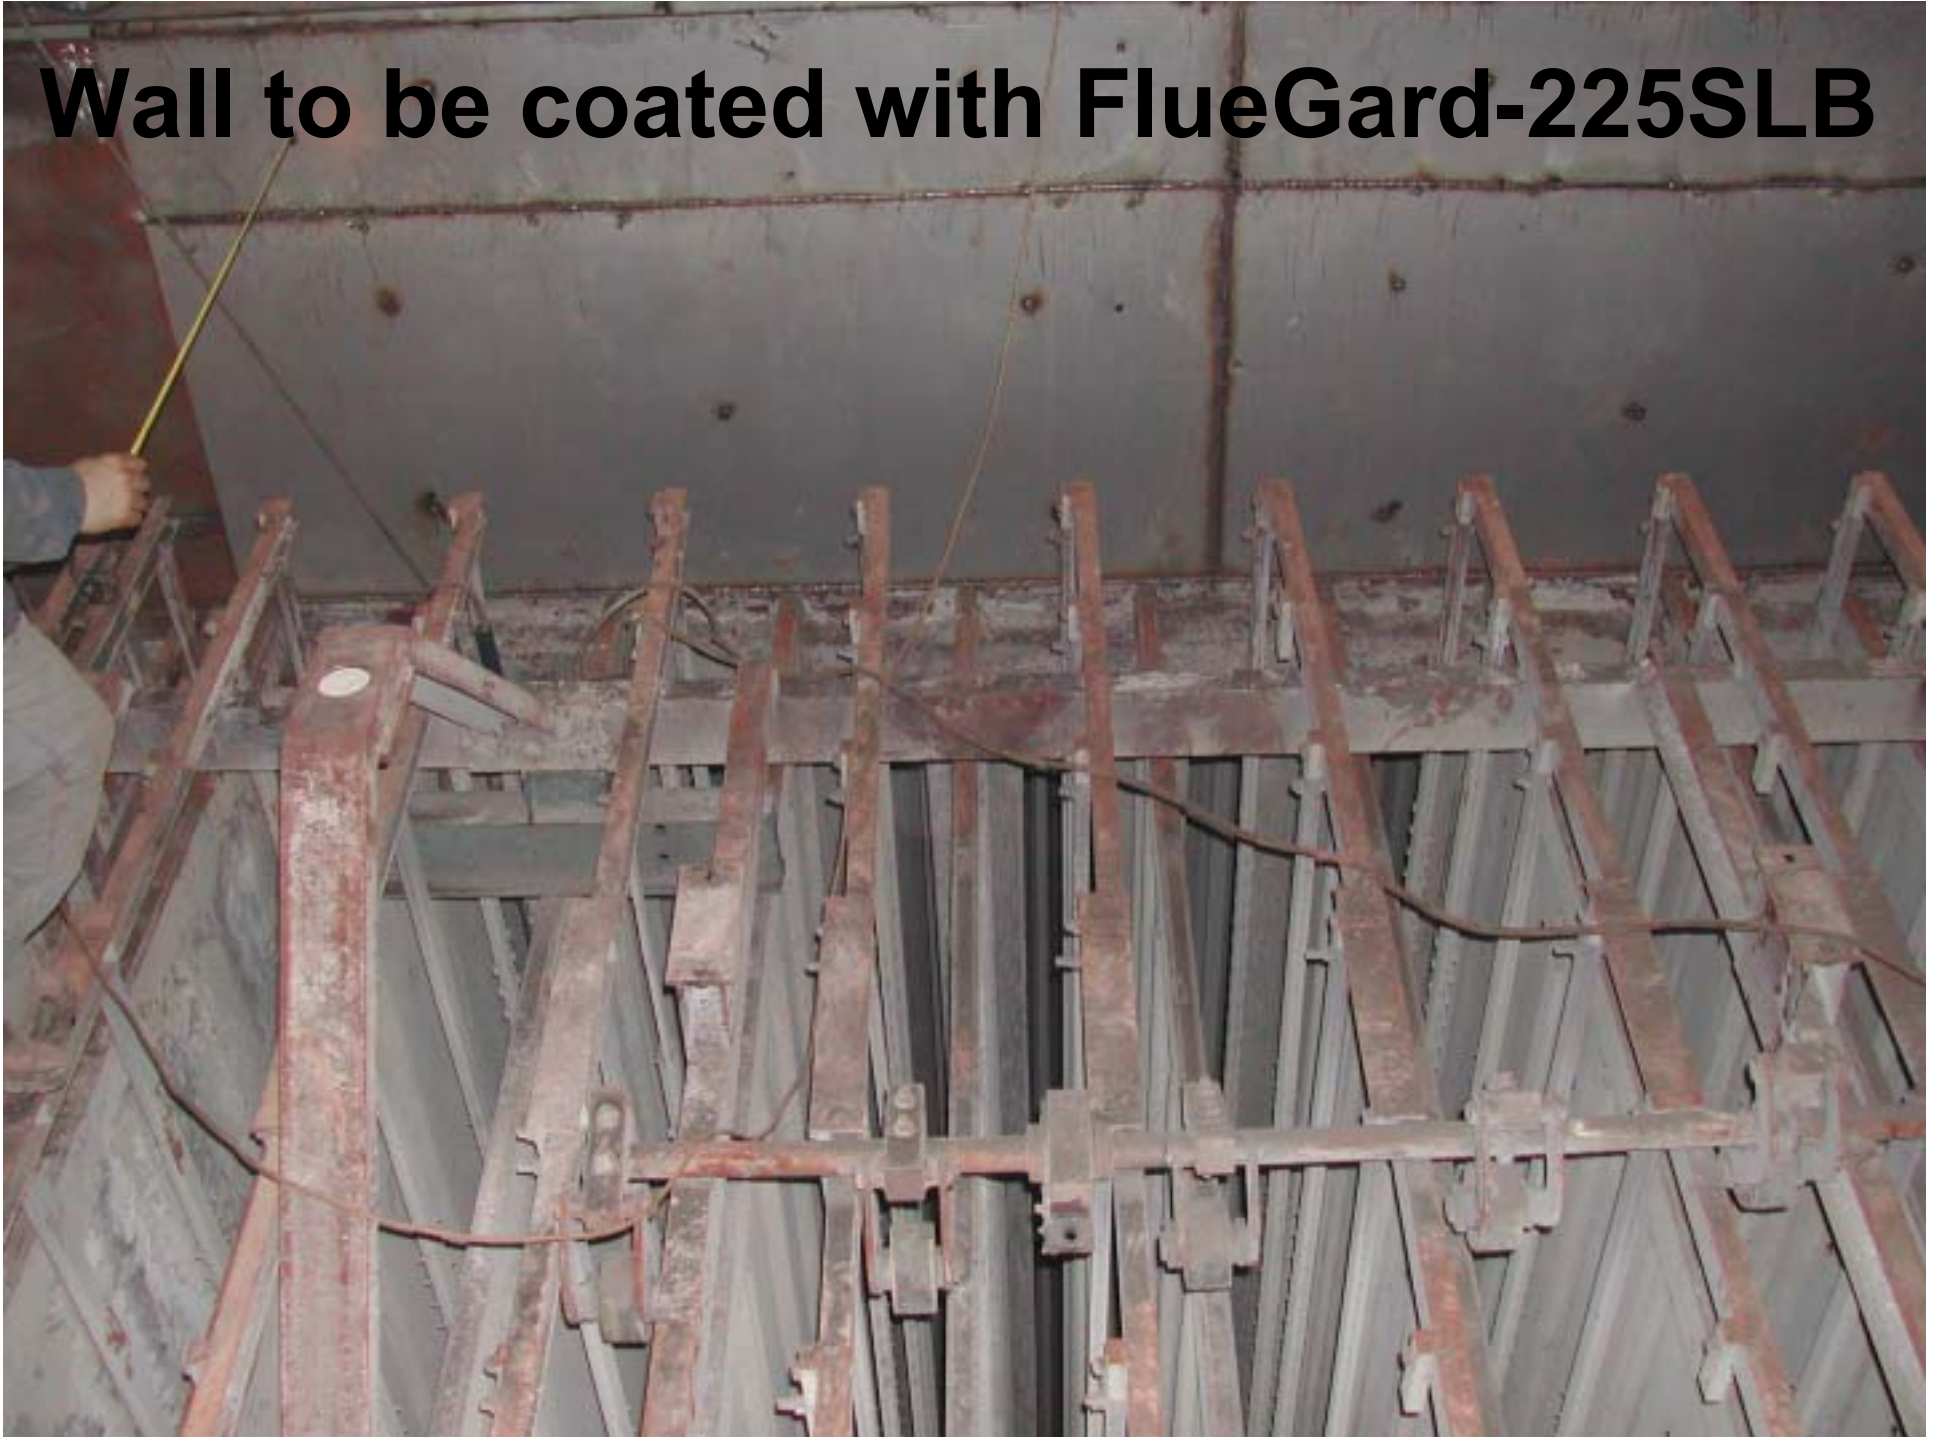
Wall to be coated with FlueGard-225SLB

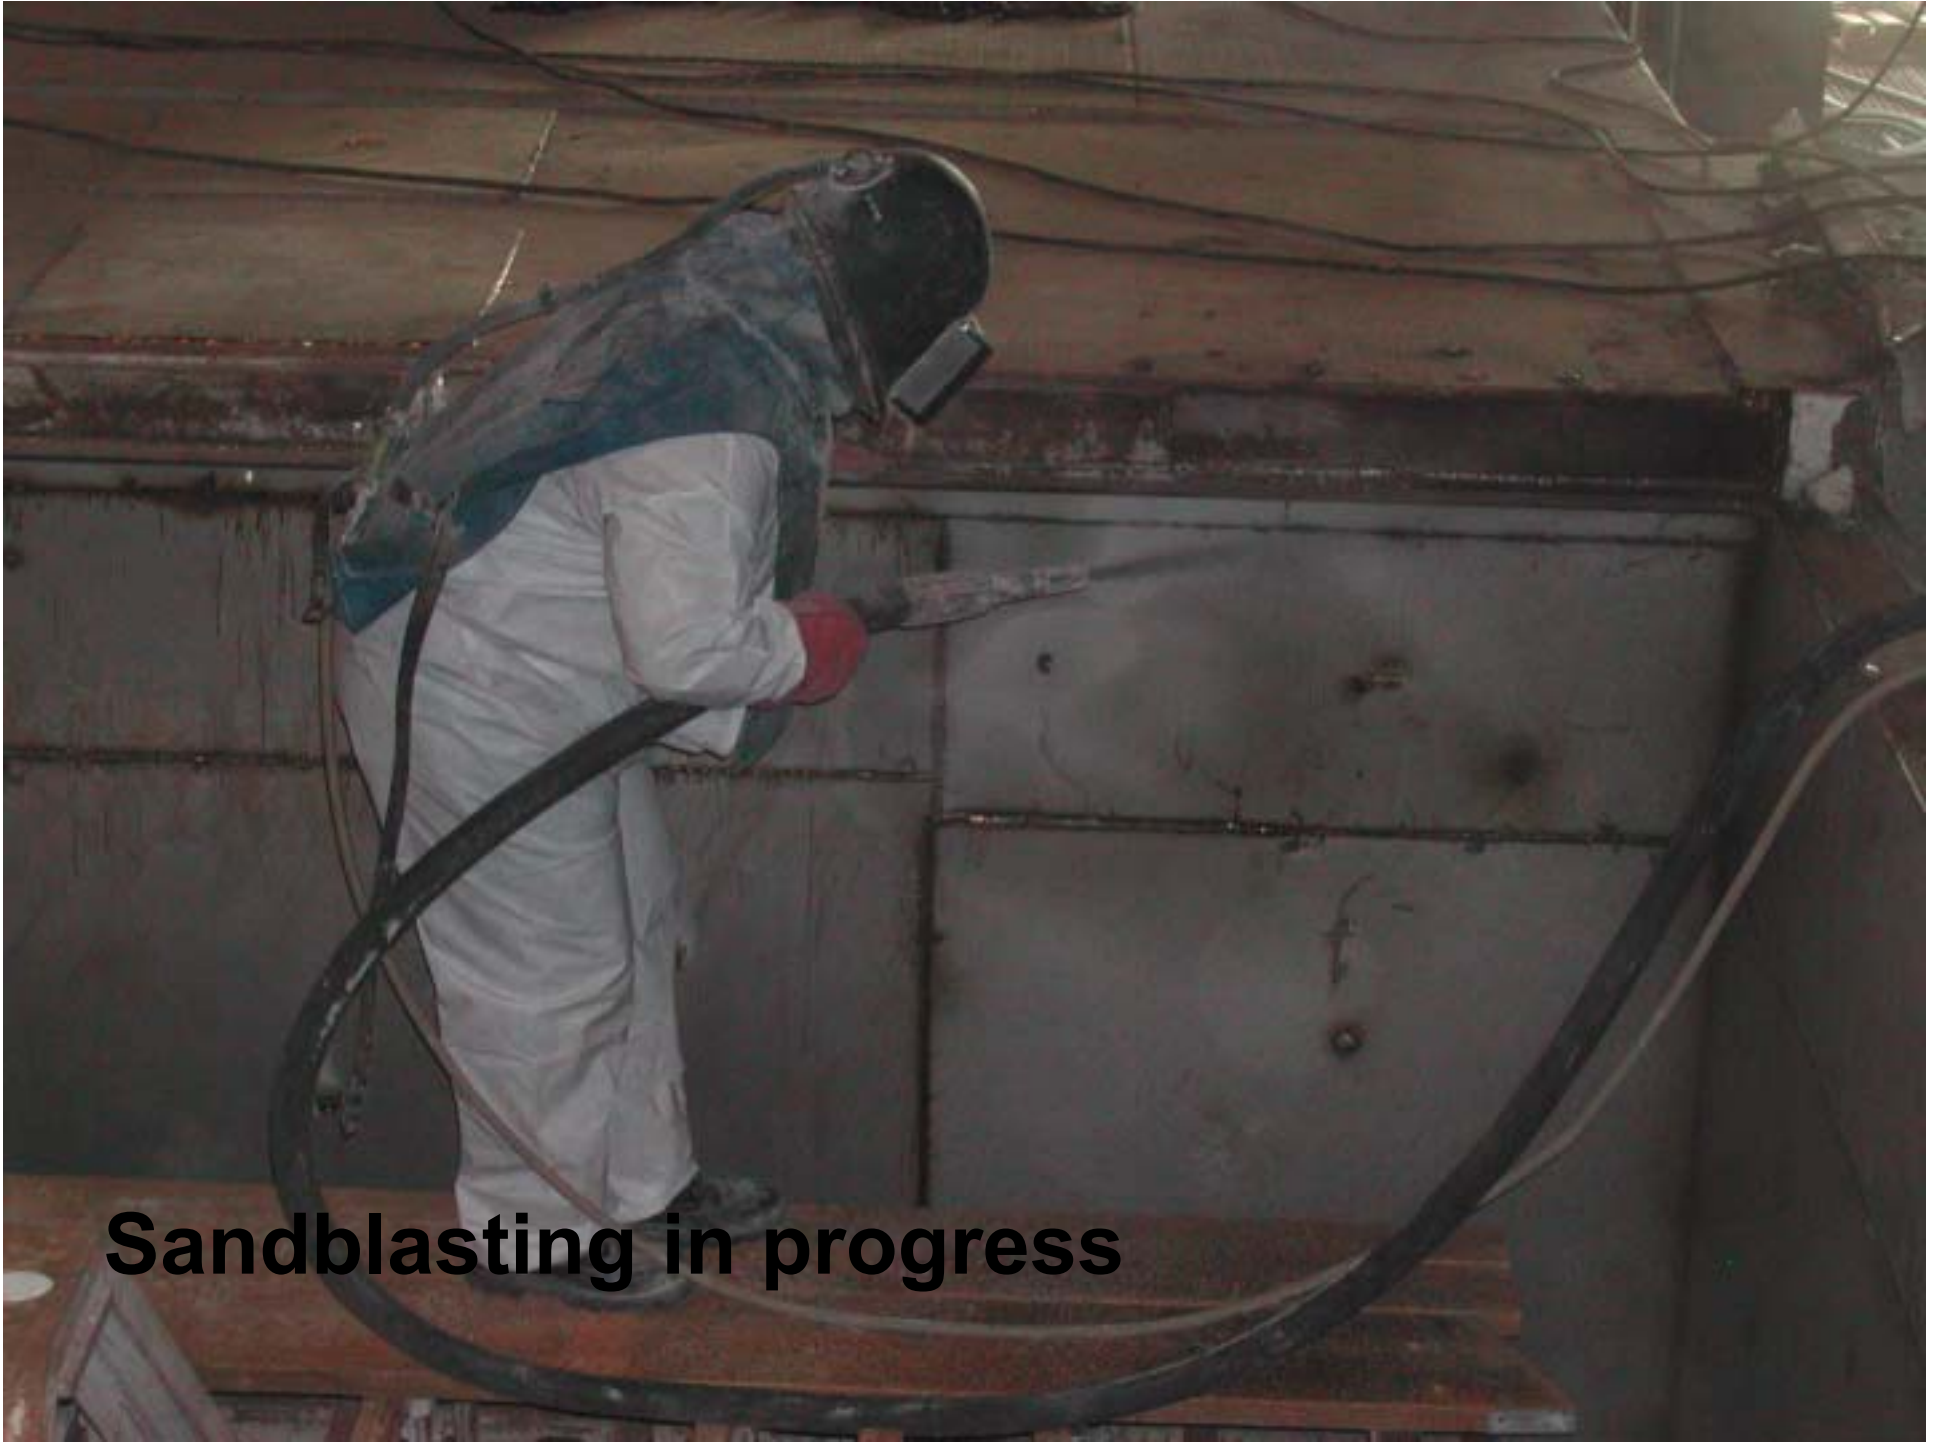
Sandblasting in progress

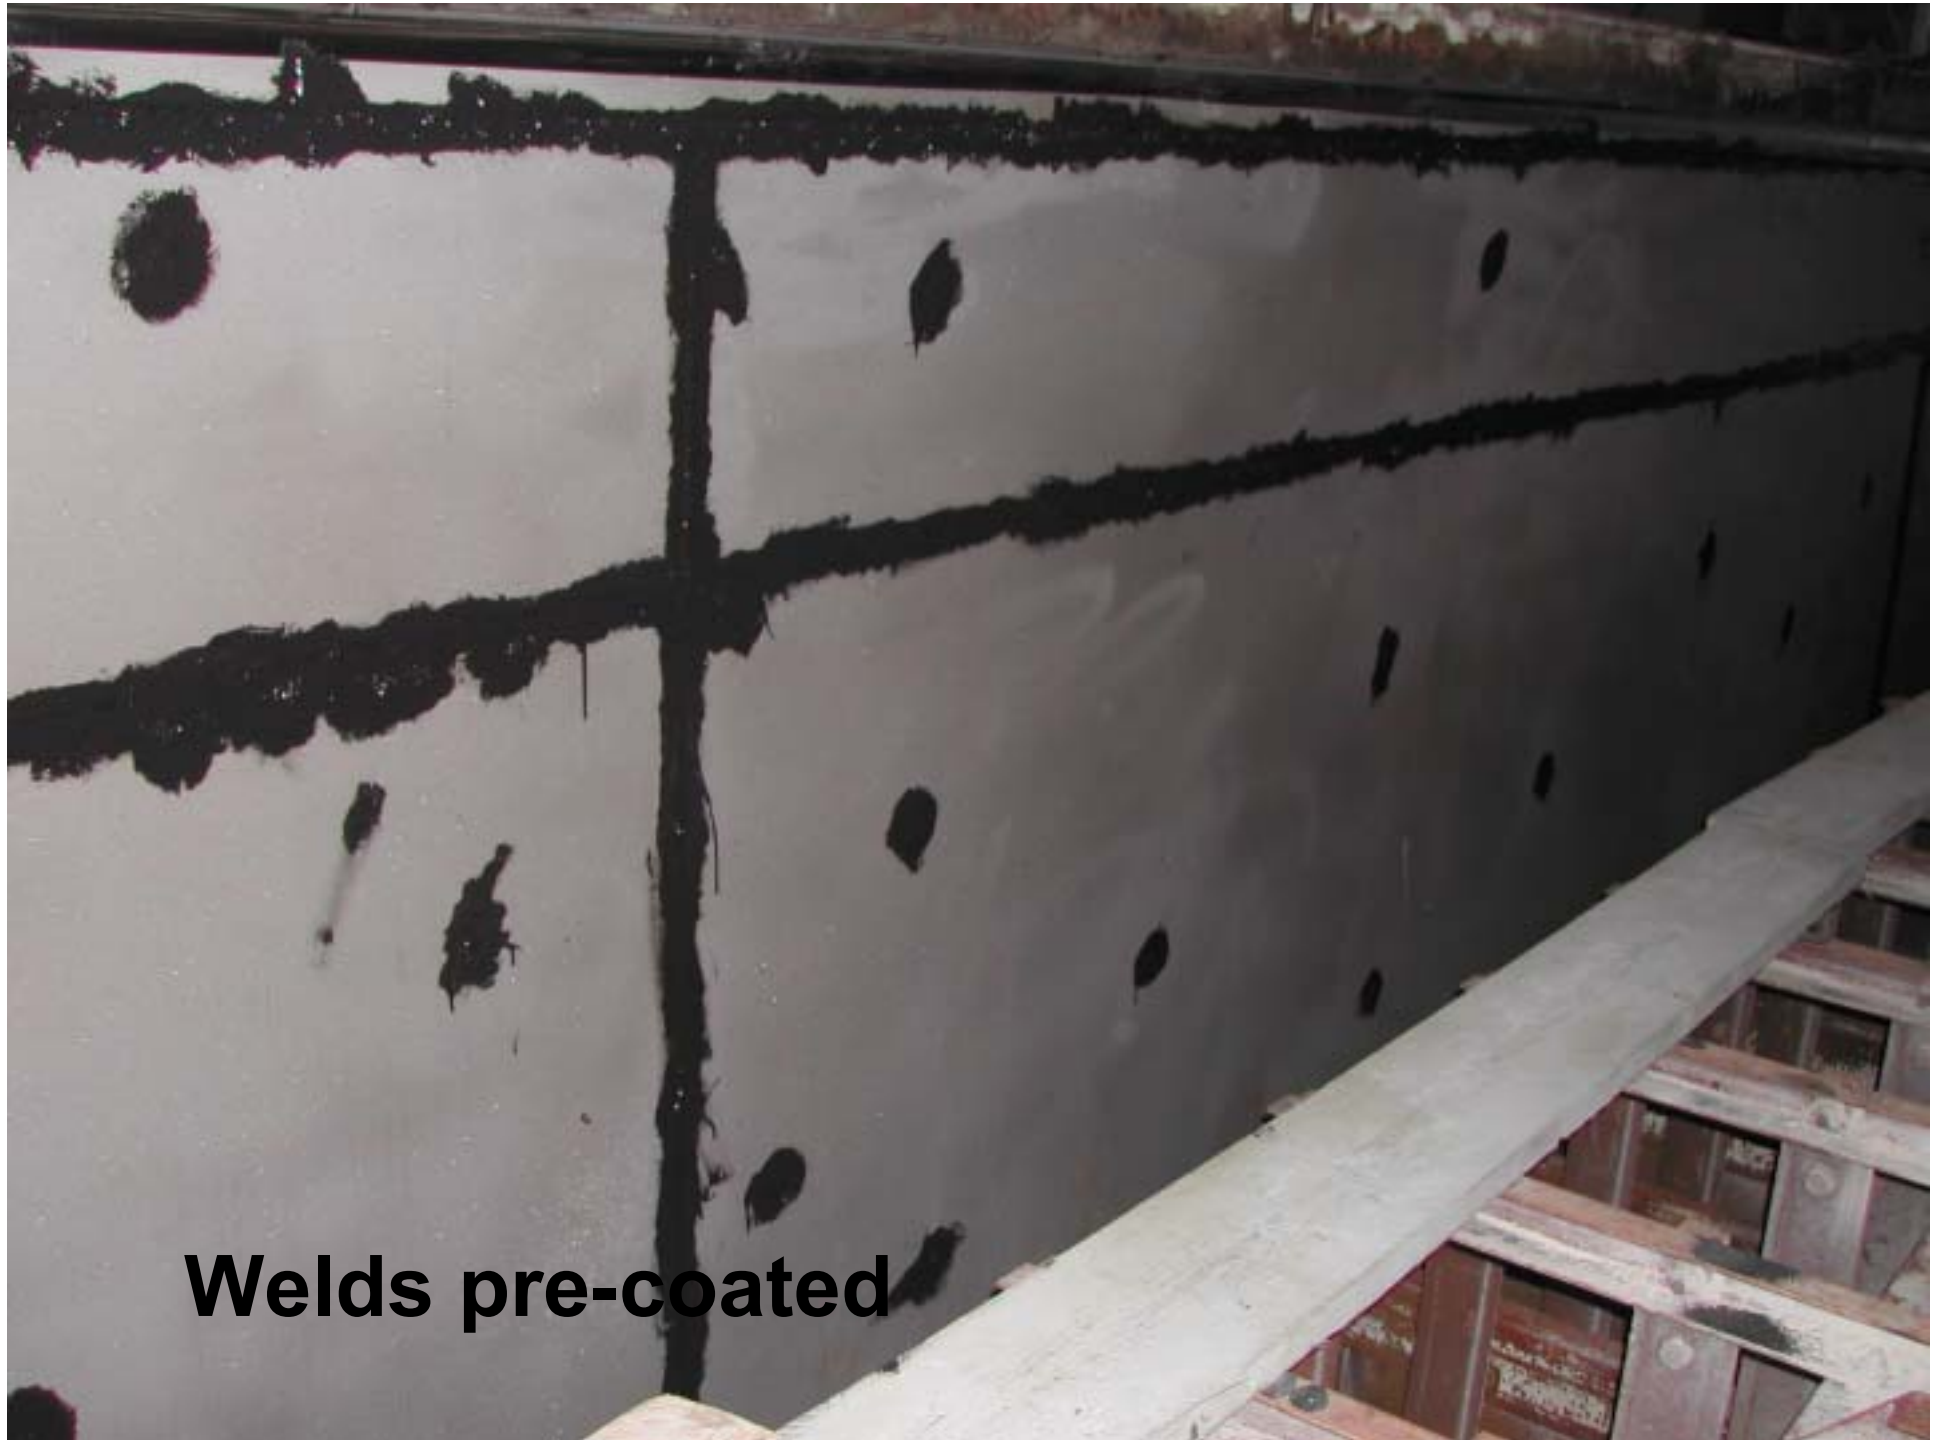
Welds pre-coated

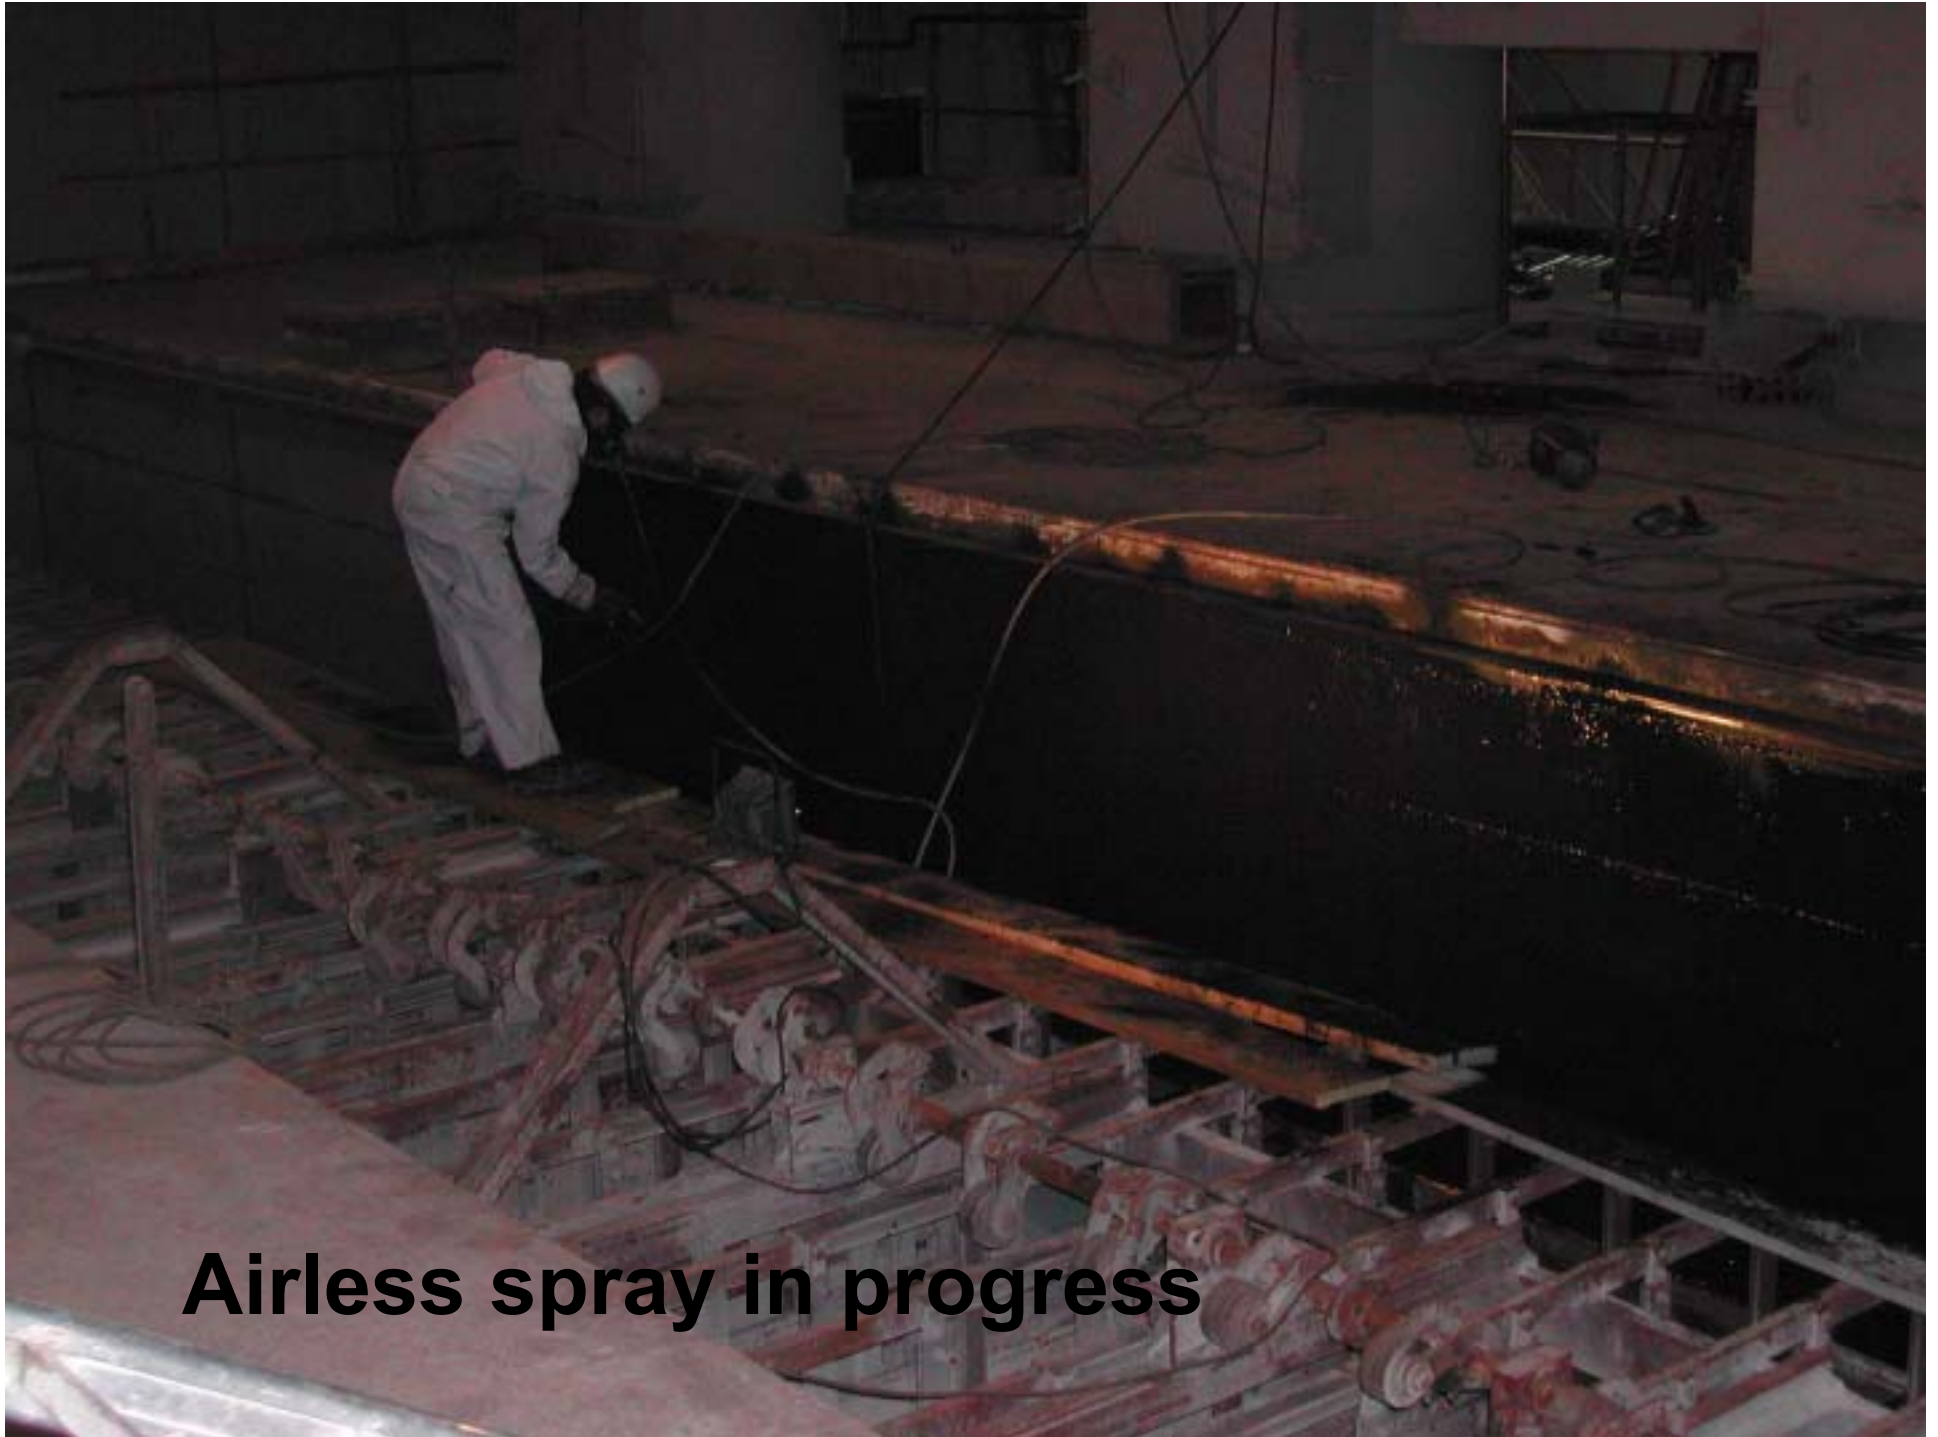
Airless spray in progress

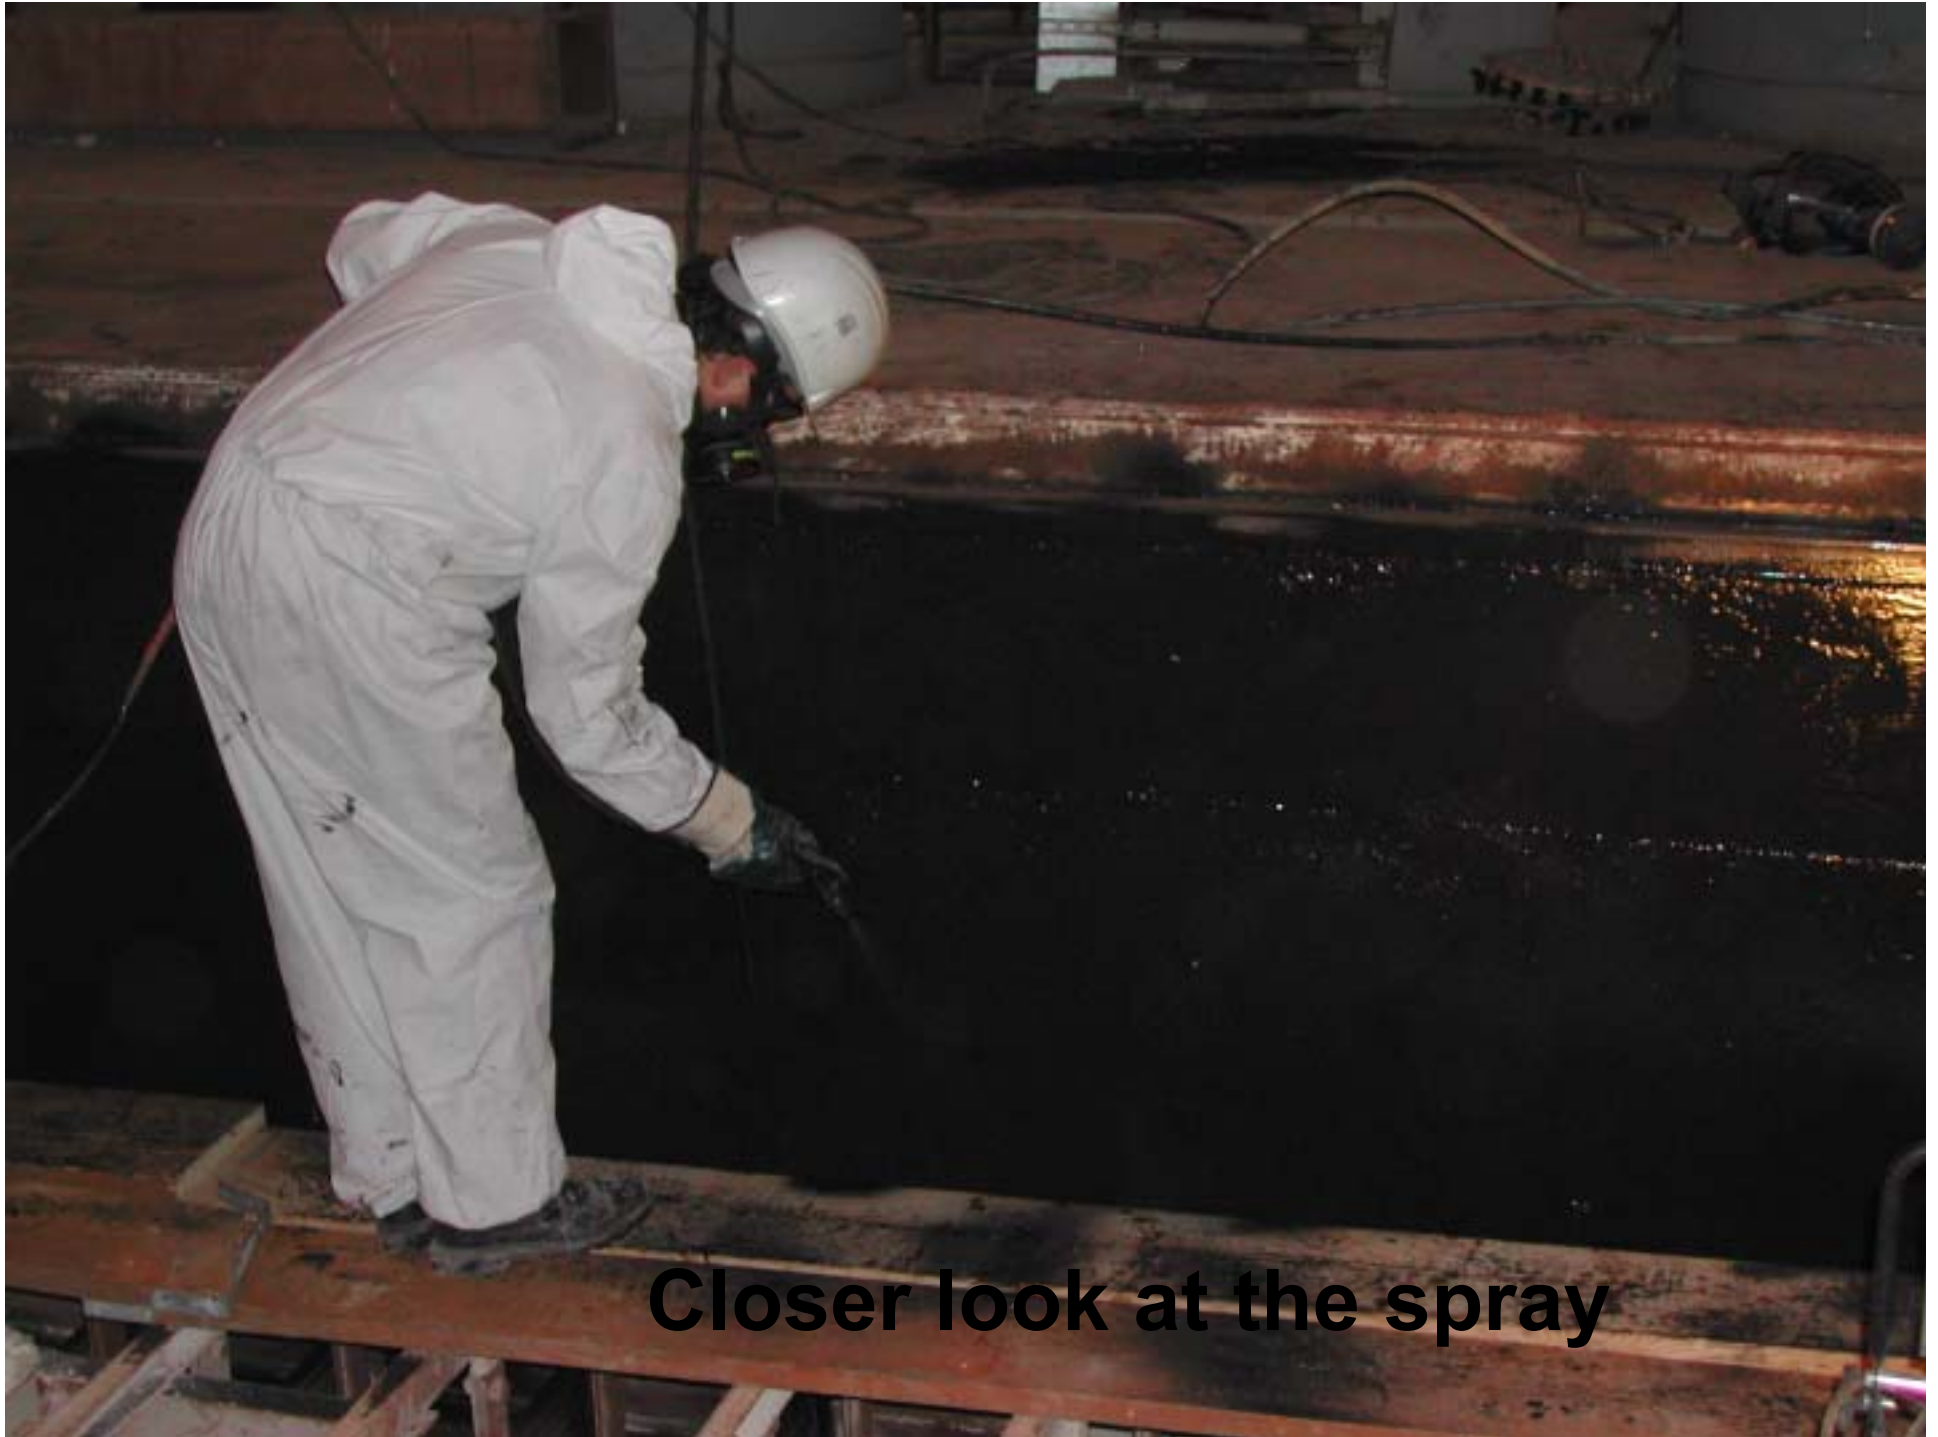
Closer look at the spray
