FlueGard-225SLB at Obourg ESP

November 2004

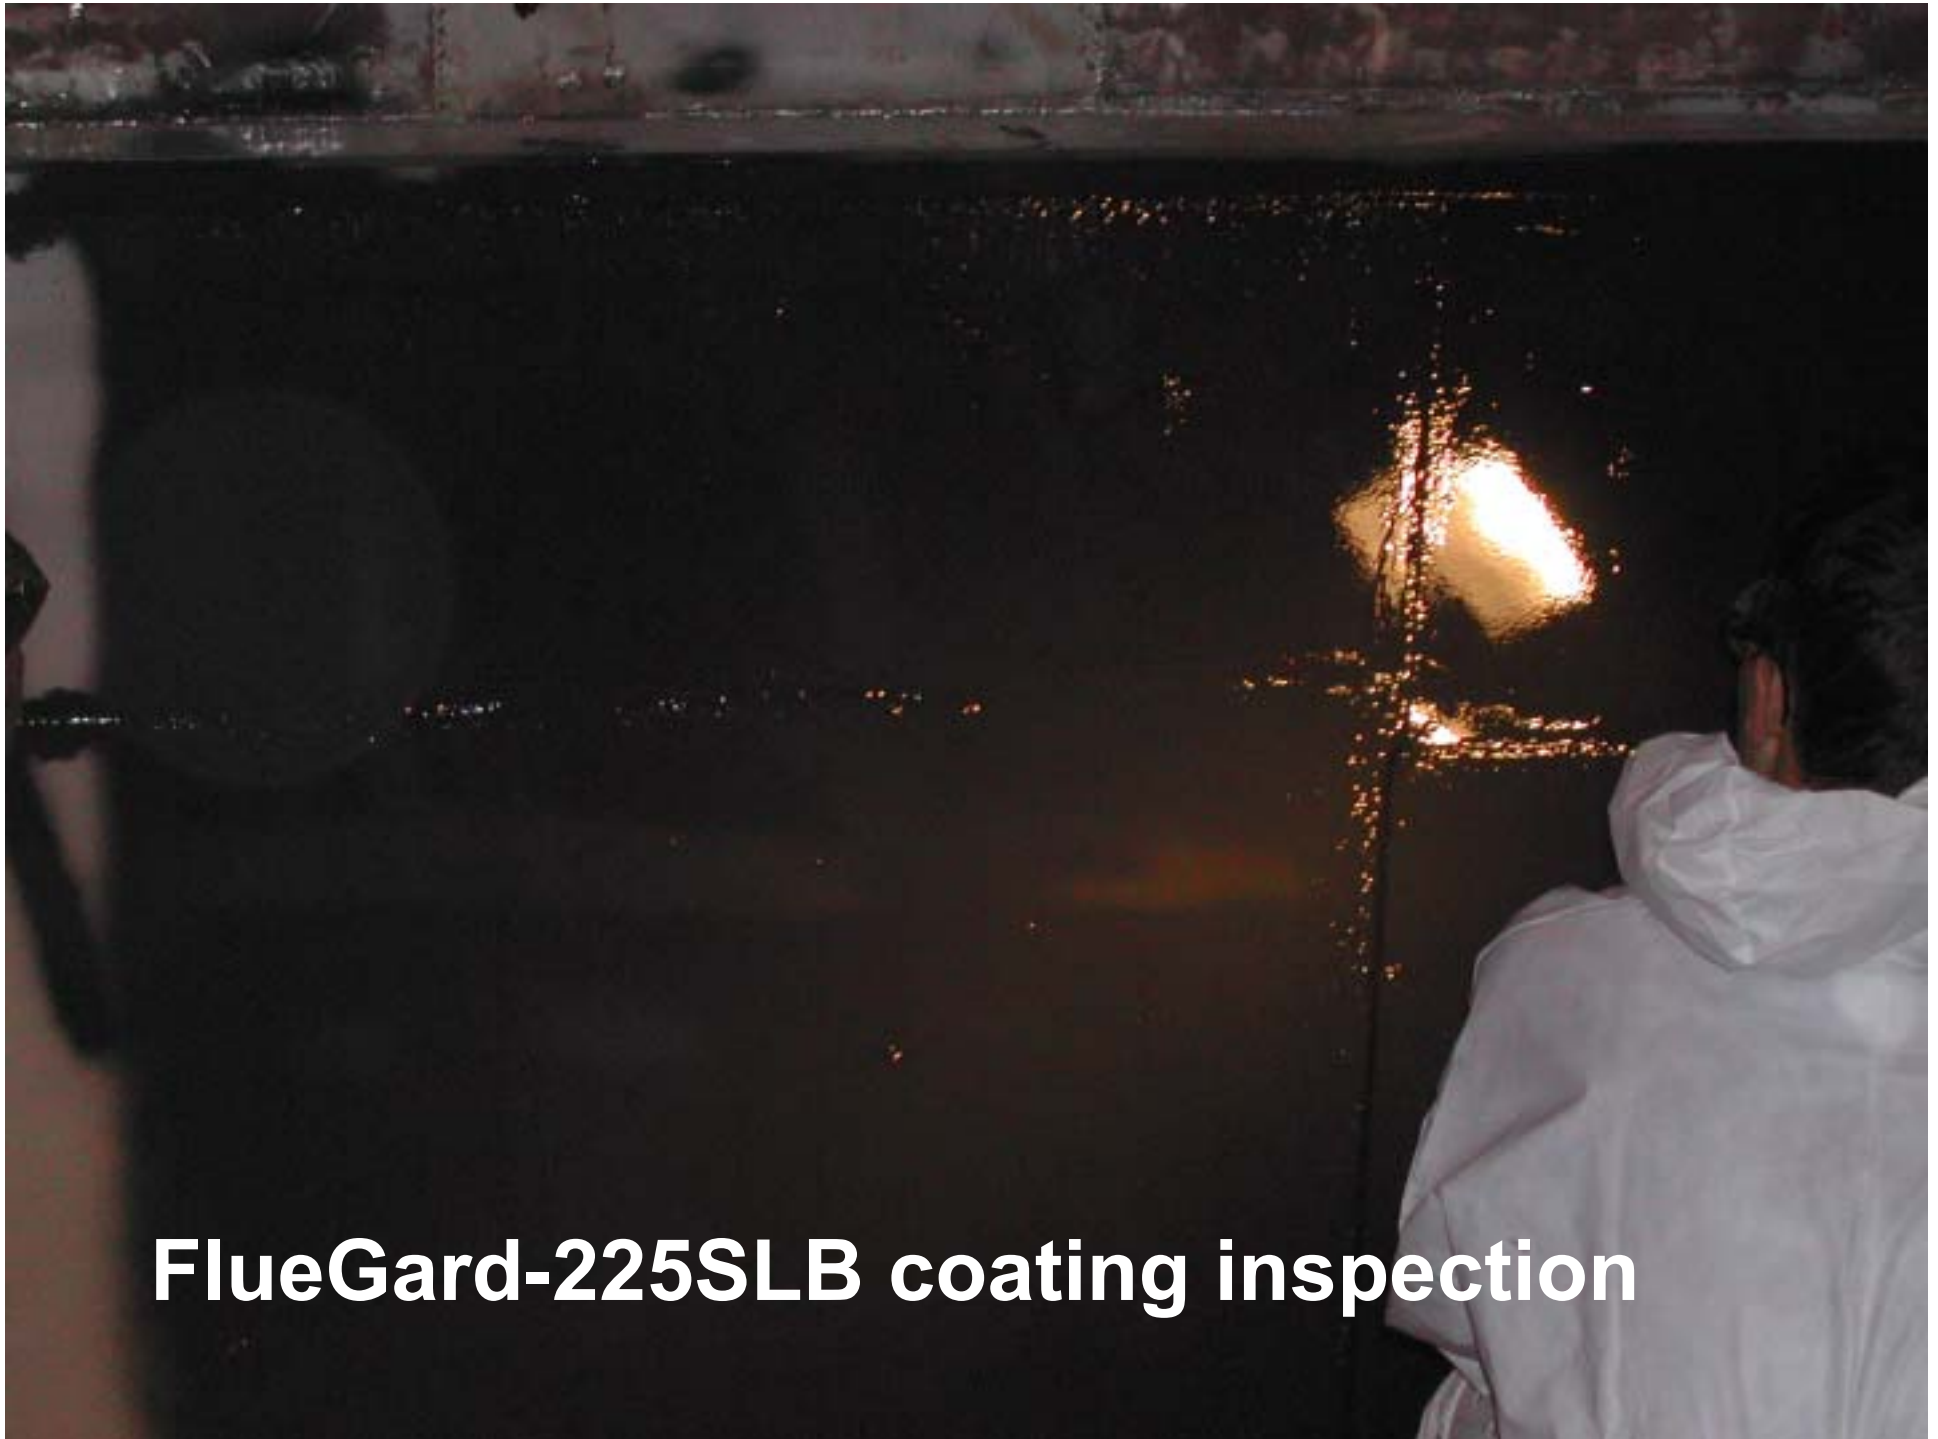
FlueGard-225SLB coating inspection

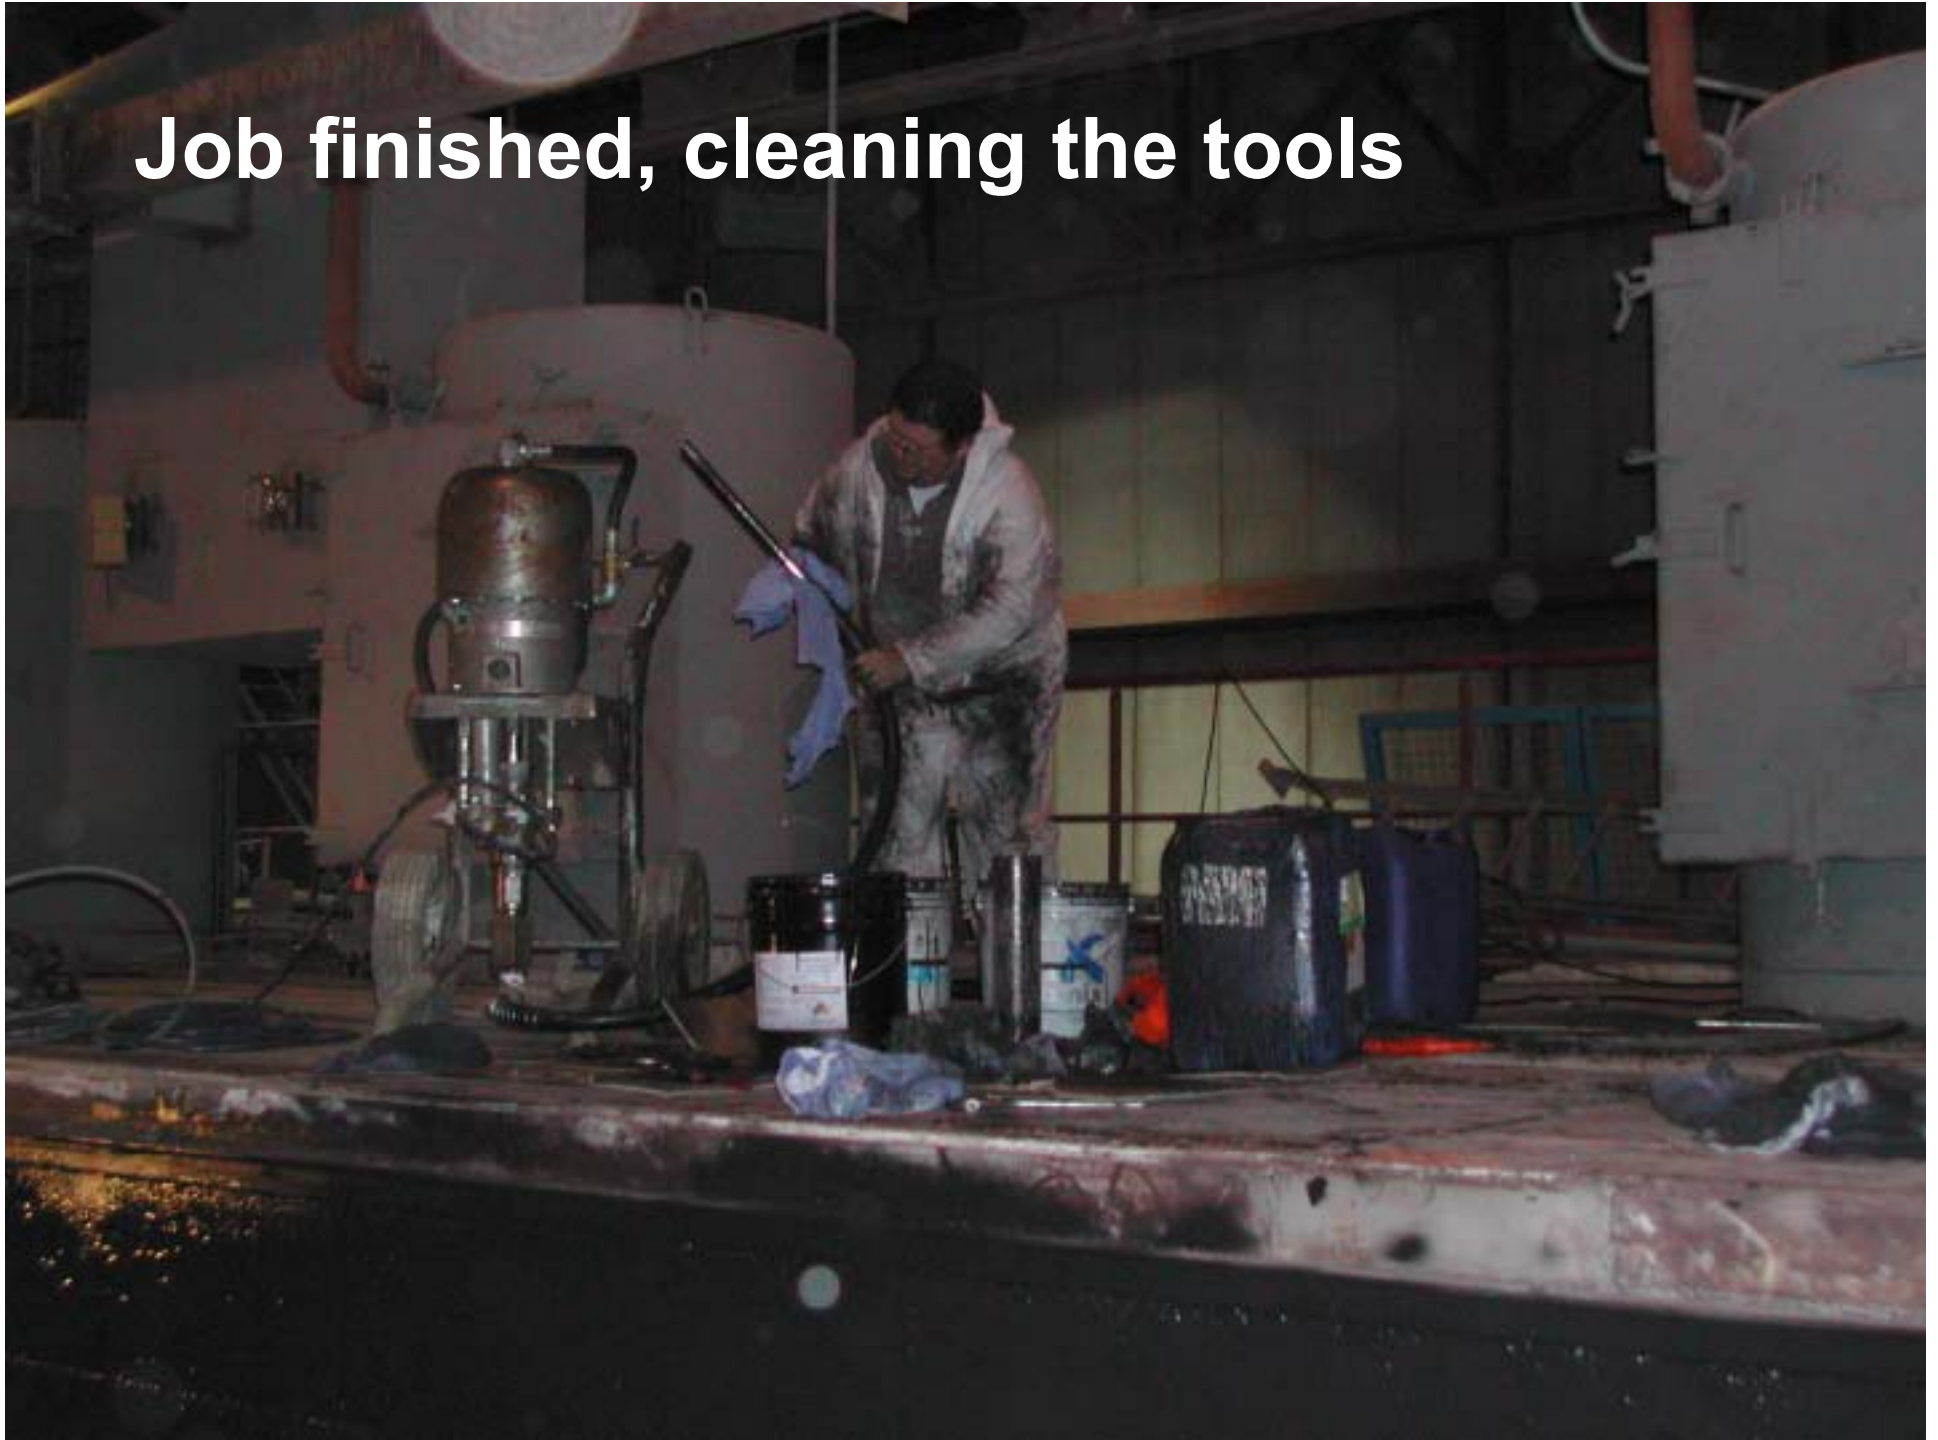
Job finished, cleaning the tools
